**Flood Control Project Maintenance
Levee Inspections**

Maintenance Issue Types Only, Levee Inspection Report By Mile - Fall 2018

Reclamation District No. 2058 Pescadero

Waterway	Bank	Unit Miles	Inspection Start/End	Inspector
Unit No. 01 Paradise Cut	Left	6.58	10/30/2018 10/30/2018	Richard Willoughby

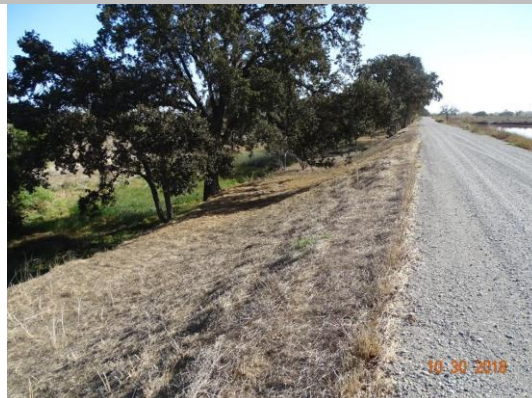
Photo 1 of 1 : FA_2018_RD2058_111_22_20181101_00057.jpg

LM Start	0.00	Rating **	A	Issue No.	22
LM End	6.58	Issue Type +	Ma	Location *	LS
Category	Earthen Levee			GPS Latitude/Longitude	
				Start	End
Item	Vegetation			37.801539 °	37.770924 °
				-121.420775 °	-121.327457 °
DWR ID	DWR_RD2058_01_f_2018_22				
Comment Code					
V1 : Control annual grass and weeds on the levee slopes and easements.					
Inspector Comment					
District used goats to control veg on landward slope.

Typical view of landward slope. (Fall 2018)

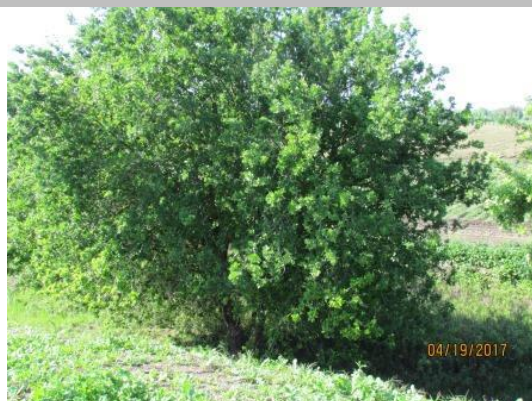
Photo 1 of 1 : FA_2018_RD2058_111_21_20180906_00013.jpg

LM Start	0.55	Rating **	M	Issue No.	21
LM End	0.55	Issue Type +	Ma	Location *	LS
Category	Earthen Levee			GPS Latitude/Longitude	
				Start	End
Item	Trim / Thin Trees			37.802369 °	37.802369 °
				-121.413902 °	-121.413902 °
DWR ID	DWR_RD2058_01_s_2017_21				
Comment Code					
T1 : Trim trees to at least five feet above ground level.					
Inspector Comment

View of the tree that needs to be trimmed.

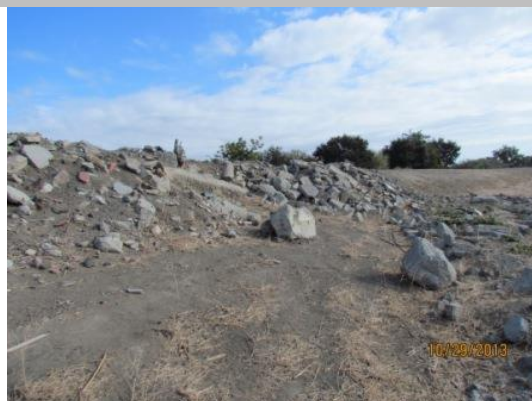
Photo 1 of 1 : FA_2018_RD2058_111_11_20180906_00006.jpg

LM Start	1.82	Rating **	U	Issue No.	11
LM End	1.83	Issue Type +	Ma	Location *	LS
Category	Earthen Levee			GPS Latitude/Longitude	
				Start	End
Item	Encroachments			37.804785 °	37.804802 °
				-121.391524 °	-121.391304 °
DWR ID	DWR_RD2058_01_f_2013_11				
Comment Code					
MA : Material					
Inspector Comment					
Pile of concrete contains rebar on landside slope obstructing visibility and access.

View of the concrete with rebar placed on the landside slope.

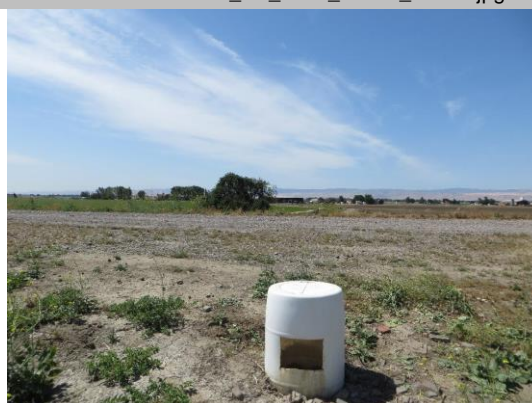
Photo 1 of 3 : UCIP_FA_2018_45865_74323.jpg

LM Start	2.12	Rating **	A/W	Issue No.	979
LM End	2.12	Issue Type +	Ma	Location *	
Category	Supplemental			GPS Latitude/Longitude	
				Start	End
Item	DWR UCIP LMA Responsibility			37.803892 °	37.803892 °
				-121.386299 °	-121.386299 °
DWR ID	22705				
Comment Code					
Inspector Comment					
FS_ID:45865 DS_ID:22705 EP_NO: N/A Repair Type: No Action Needed Crossing Status: Found UCIP Comments: FIELD_STRUCT_DESC: 20-inch steel drainage discharge pipe through the levee, 8 feet below the crown. Pump on a concrete sump in a drainage ditch on the landside (LS) toe. Siphon breaker on the waterside (WS) shoulder. [Additional Reference(s): USACE San Joaquin O&M Manual 10, March 1964, (HLM 2.14), 18-inch pipe referenced]. FS Date: 5/12/2015

Siphon breaker on WS shoulder inside protective riser.

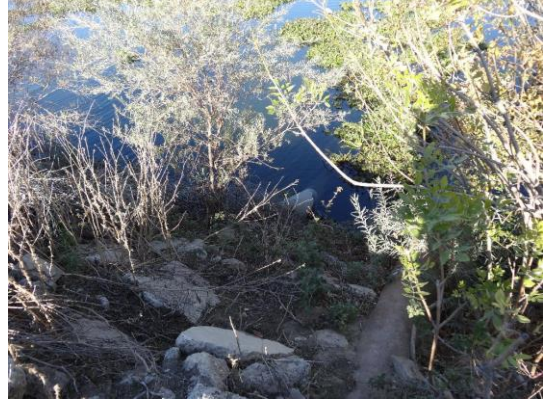
Photo 2 of 3 : UCIP_FA_2018_45865_74324.jpg

Pipe just visible at WS toe at center of photograph.

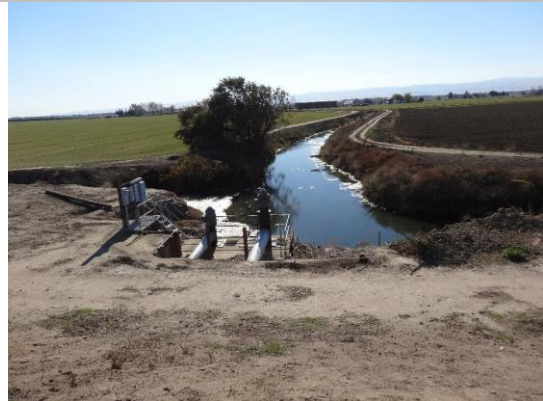
Photo 3 of 3 : UCIP_FA_2018_45865_74325.jpg

Pump on concrete pad at LS toe.

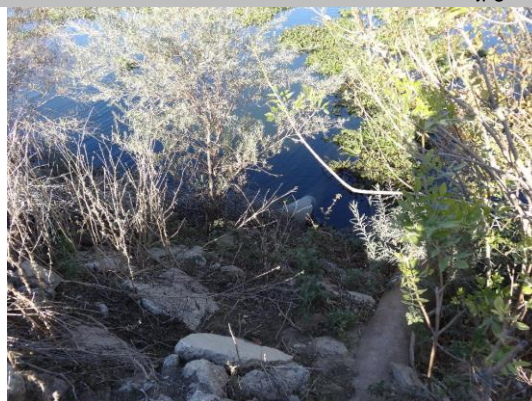
Photo 1 of 3 : UCIP_FA_2018_51699_45192.jpg

LM Start	2.12	Rating **	M	Issue No.	980	
LM End	2.12	Issue Type +	Ma	Location *		
Category	Supplemental			GPS Latitude/Longitude		
				Start		End
Item	DWR UCIP LMA Responsibility			37.803886 °		37.803886 °
				-121.386271 °		-121.386271 °
DWR ID	22706					
Comment Code						
Inspector Comment						
FS_ID:51699 DS_ID:22706 EP_NO: N/A Repair Type: Non-Urgent Crossing Status: Found UCIP Comments: Leaky and damaged siphon breaker on waterside shoulder.. FIELD_STRUCT_DESC: 16-inch steel drainage discharge pipe through the levee, 8 feet below the crown. Pump on a concrete sump in a drainage ditch on the landside (LS) toe. Siphon breaker on the waterside (WS) shoulder. [Additional Reference(s): USACE San Joaquin O&M Manual 10, March 1964, (HLM 2.14), 12-inch pipe referenced]. FS Date: 5/13/2015

WS view: exposed steel pipe (right) on channel bank.

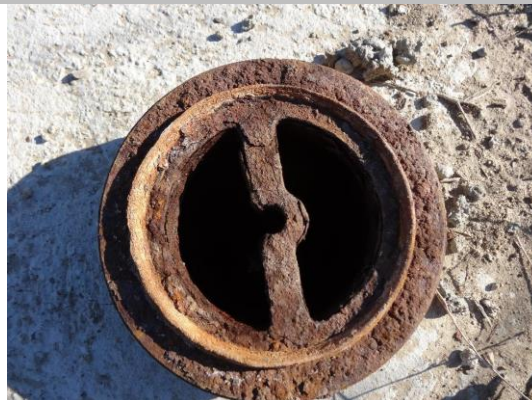
Photo 3 of 3 : UCIP_FA_2018_51699_45190.jpg

WS view: Upper part of the siphon breaker missing.

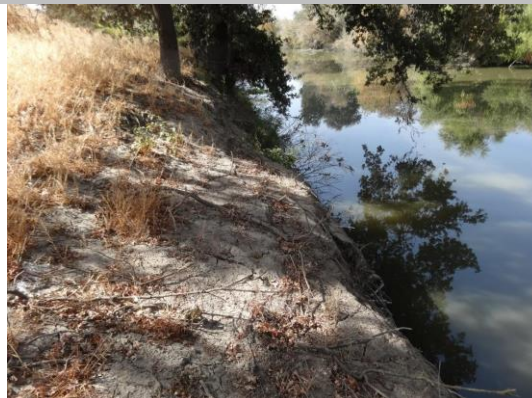
Photo 1 of 4 : FA_2018_RD2058_111_1_20180906_00001.jpg

10/10/2017: No significant change observed.
 07/20/2016: No significant change observed.
 08/04/2015: No significant change observed.
 08/26/2014: No significant change observed.
 08/28/2013: No significant change observed.
 07/26/2012: The site has been visited, and no significant change has been observed.
 09/02/2011: This site was not visited due to the time limit.
 09/22/2010: No significant change observed. Minor pocket erosions are lined at the lower bank. Two large Oak and Willow trees are on mid-slope and bench. The remaining bench was re-measured and found to be approximately 10 feet. There was no indication of active erosion on site during the site visit.
 08/05/2010: Recommended for annual assessment and monitoring of the site during flood events, per CLRO.
 07/23/2009: No major change observed since last visit; site is a 200-ft. long near-vertical berm erosion; recommend annual assessment and monitoring of the erosion site, per CLRO CES Evaluation 2008 Report; Site # is the same site previously reported as RM4.0,LM4.51; previously rated "U".

09/10/2008: Two large trees (2-3' DBH) with partial roots exposed.
 2007: Visited site 03/13/2007. [2017 Site ID:RD2058U01RM3.97]

Direct view of the pocket erosion site.

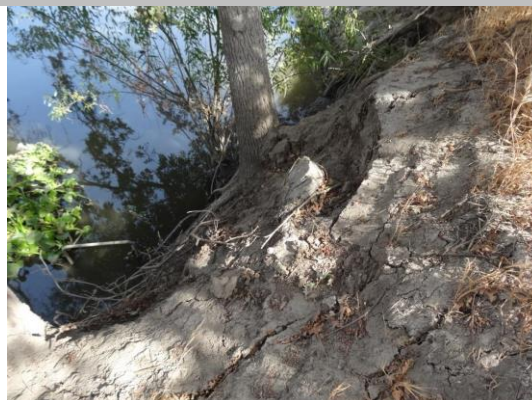
Photo 2 of 4 : FA_2018_RD2058_111_1_20180906_00002.jpg

Direct view of the erosion near a tree.

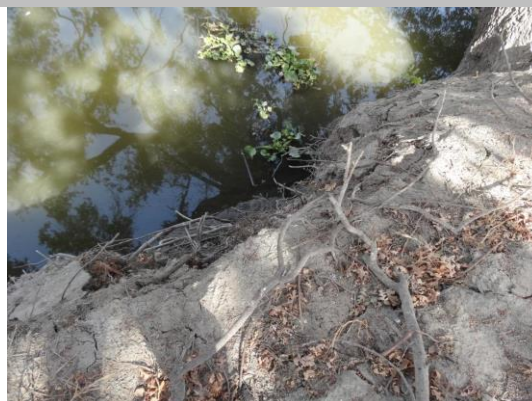
Photo 3 of 4 : FA_2018_RD2058_111_1_20180906_00003.jpg

Close view of the erosion.

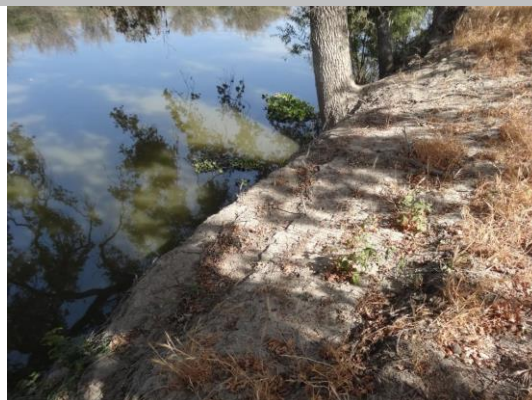
Photo 4 of 4 : FA_2018_RD2058_111_1_20180906_00004.jpg

Direct view of the erosion near a tree.

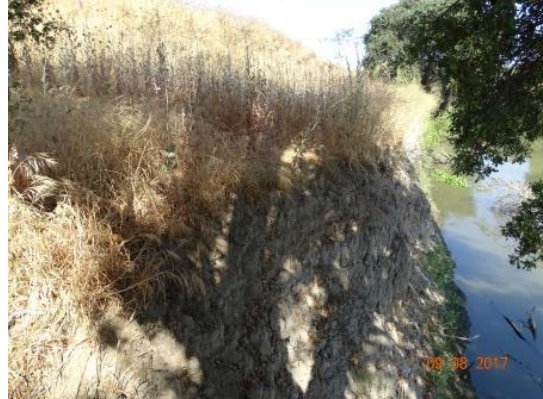
Photo 2 of 5 : FA_2018_RD2058_111_40_20180906_00022.jpg

Another downstream view of the erosion.

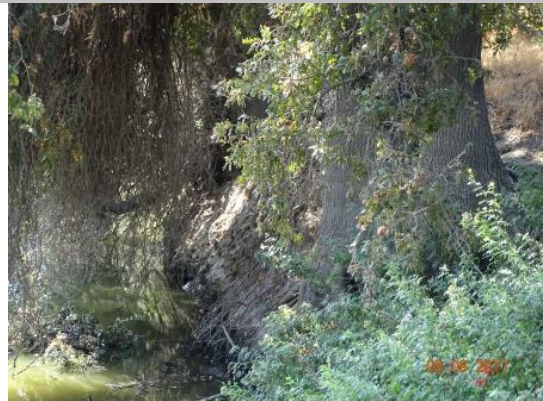
Photo 3 of 5 : FA_2018_RD2058_111_40_20180906_00023.jpg

Upstream view of the erosion site.

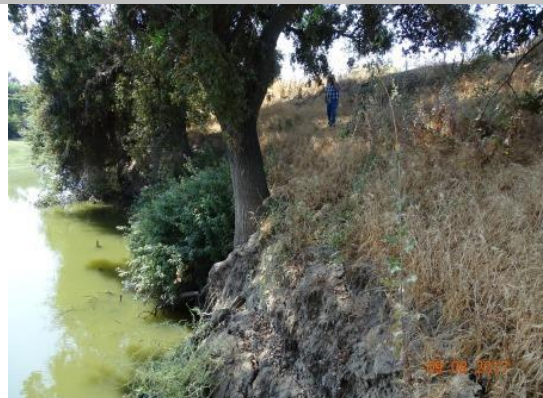
Photo 4 of 5 : FA_2018_RD2058_111_40_20180906_00024.jpg

Another upstream view of the erosion site.

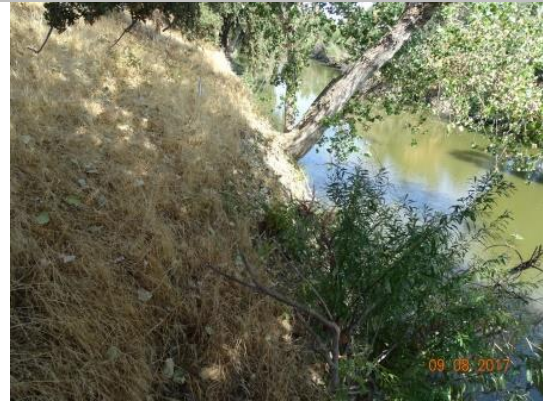
Photo 3 of 3 : FA_2018_RD2058_111_15_20180906_00010.jpg

Downstream view of the erosion site.

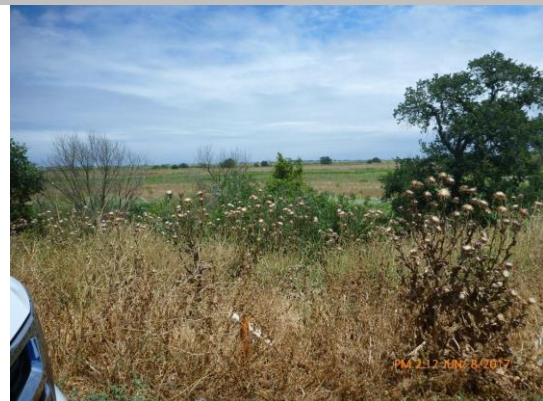
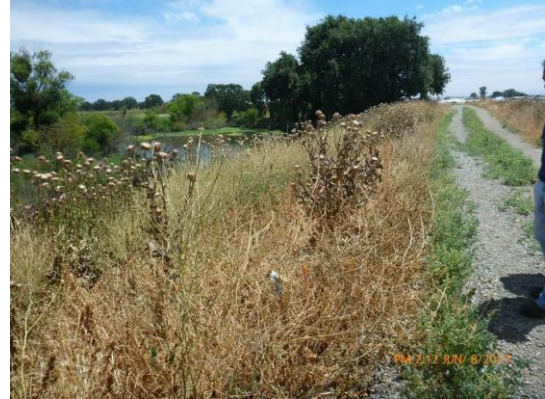
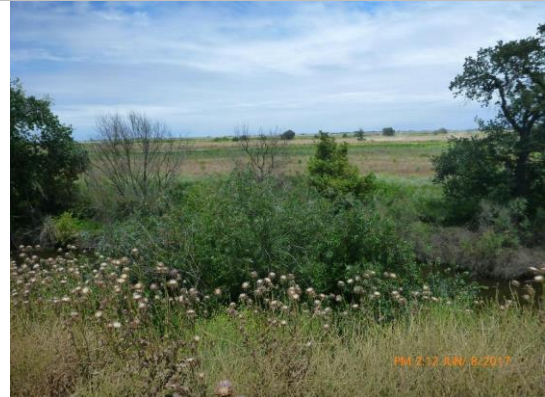
LM Start	4.77	Rating **	A/W	Issue No.	44
LM End		Issue Type +	Ma	Location *	
Category	Supplemental			GPS Latitude/Longitude	
				Start	End
Item	2017 Storm Damage			37.785862 °	°
				-121.350303 °	°
DWR ID	DWR_RD2058_01_f_2017_44				
Comment Code					
Inspector Comment					
Levee Evaluation Comments					
Description:					
Site ID No:100					
Site Designation:FSRP-14-25					
Repair Type: Erosion					
Rating:Area of Concern					
Field Date:6/8/2017					
Notes: vegetation too dense to evaluate damage. The erosion has about a 3 foot vertical cut at the waterside levee toe as of the Fall 2017 Inspection. Turned back over to Evaluators for re-assessment.

LM Start	4.77	Rating **	A/W	Issue No.	44 (cont)	
LM End		Issue Type +	Ma	Location *		
Category	Supplemental			GPS Latitude/Longitude		
				Start	End	
Item	2017 Storm Damage			37.785862 °		°
				-121.350303 °		°
DWR ID	DWR_RD2058_01_f_2017_44					
Comment Code						
Inspector Comment						
Levee Evaluation Comments						
Description:						
Site ID No:100						
Site Designation:FSRP-14-25						
Repair Type: Erosion						
Rating:Area of Concern						
Field Date:6/8/2017						
Notes: vegetation too dense to evaluate damage. The erosion has about a 3 foot vertical cut at the waterside levee toe as of the Fall 2017 Inspection. Turned back over to Evaluators for re-assessment.

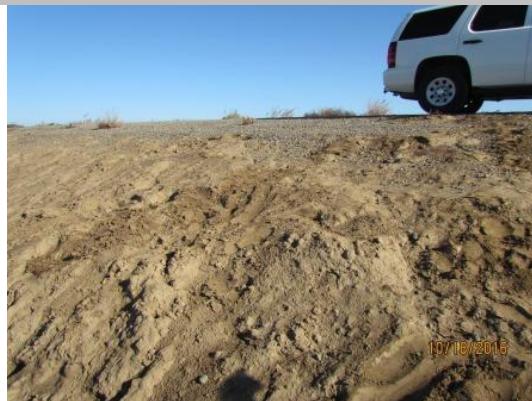
Photo 1 of 1 : FA_2018_RD2058_111_28_20180906_00014.jpg

LM Start	5.97	Rating **	A/W	Issue No.	28
LM End	5.97	Issue Type +	Ma	Location *	LS
Category	Earthen Levee			GPS Latitude/Longitude	
				Start	End
Item	Animal Control			37.774886 °	37.774886 °
				-121.335122 °	-121.335122 °
DWR ID	DWR_RD2058_01_s_2016_28				
Comment Code					
A3 : No rodents visible, but rodent burrows visible; need to backfill and compact or grout burrows.					
Inspector Comment

View of the rodent holes on the levee slope.
